**PROPERTY CONDITION ASSESSMENT
OF
WORLD TRADE CENTER PORTFOLIO**

SUBGRADE

**Property #7
Merritt & Harris, Inc. Project Number 20-251E**

**Re: Due Diligence Physical Condition Survey
World Trade Center
New York, New York**

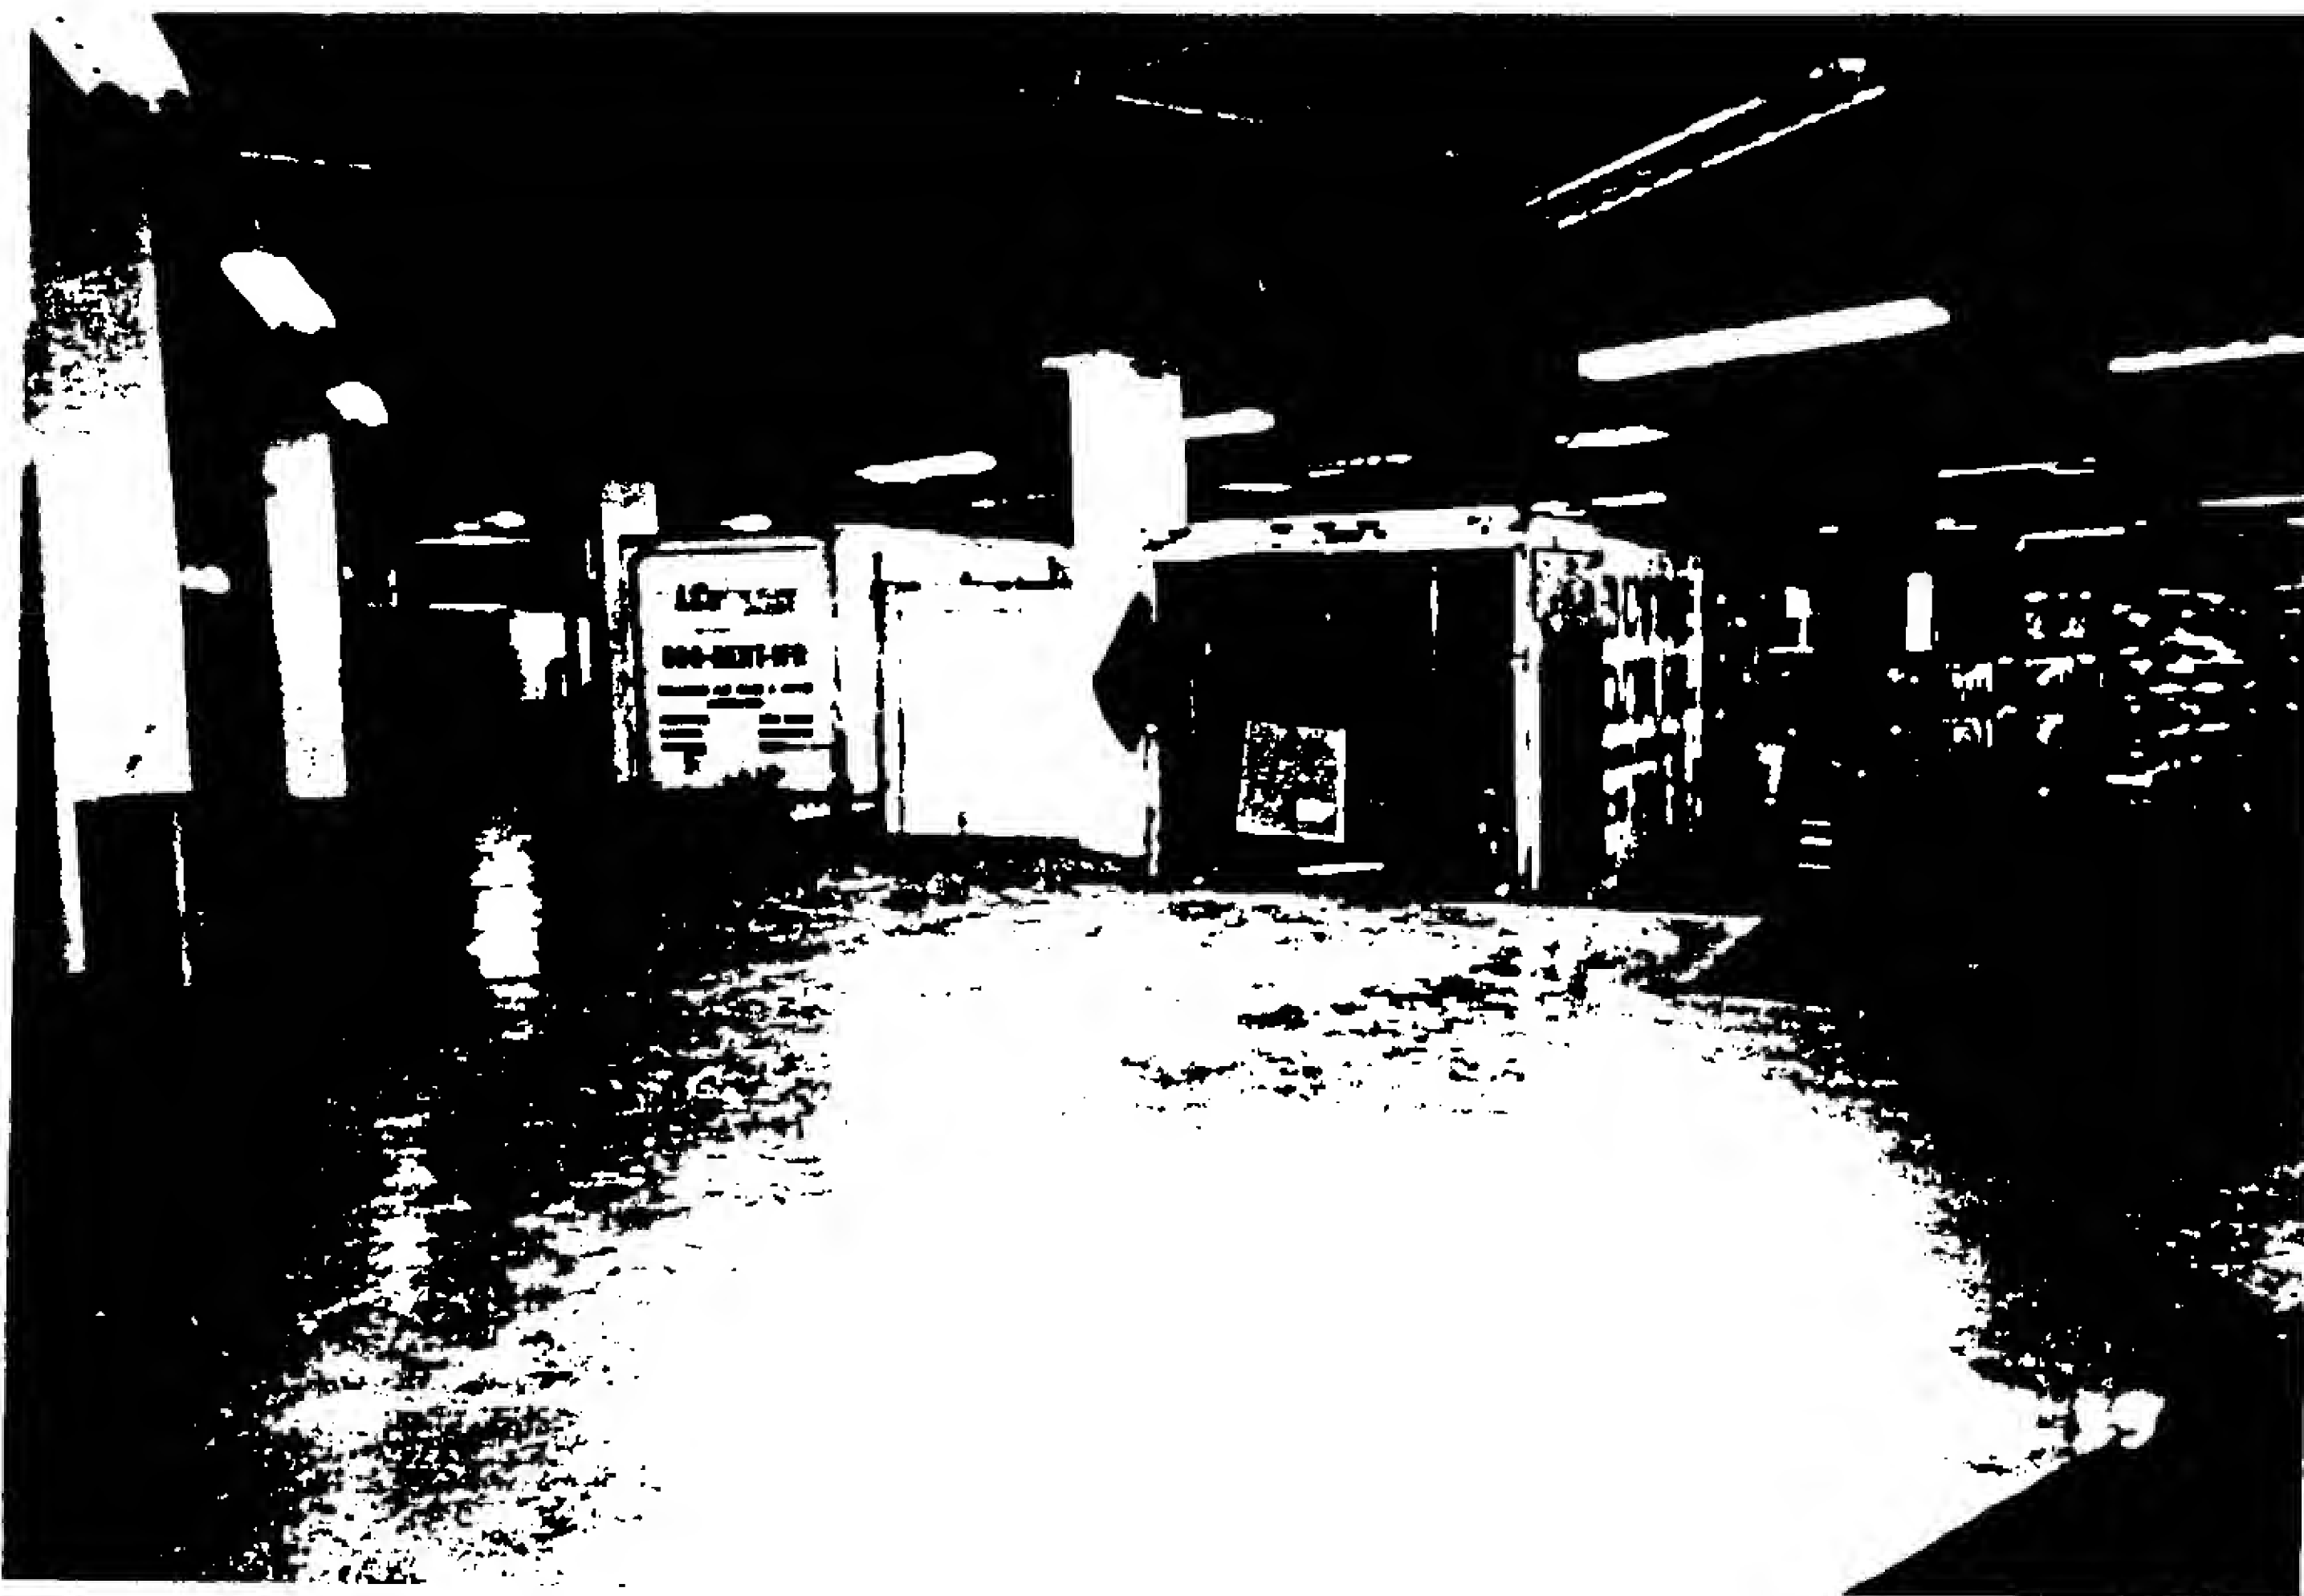
Photograph 10

Loading dock area

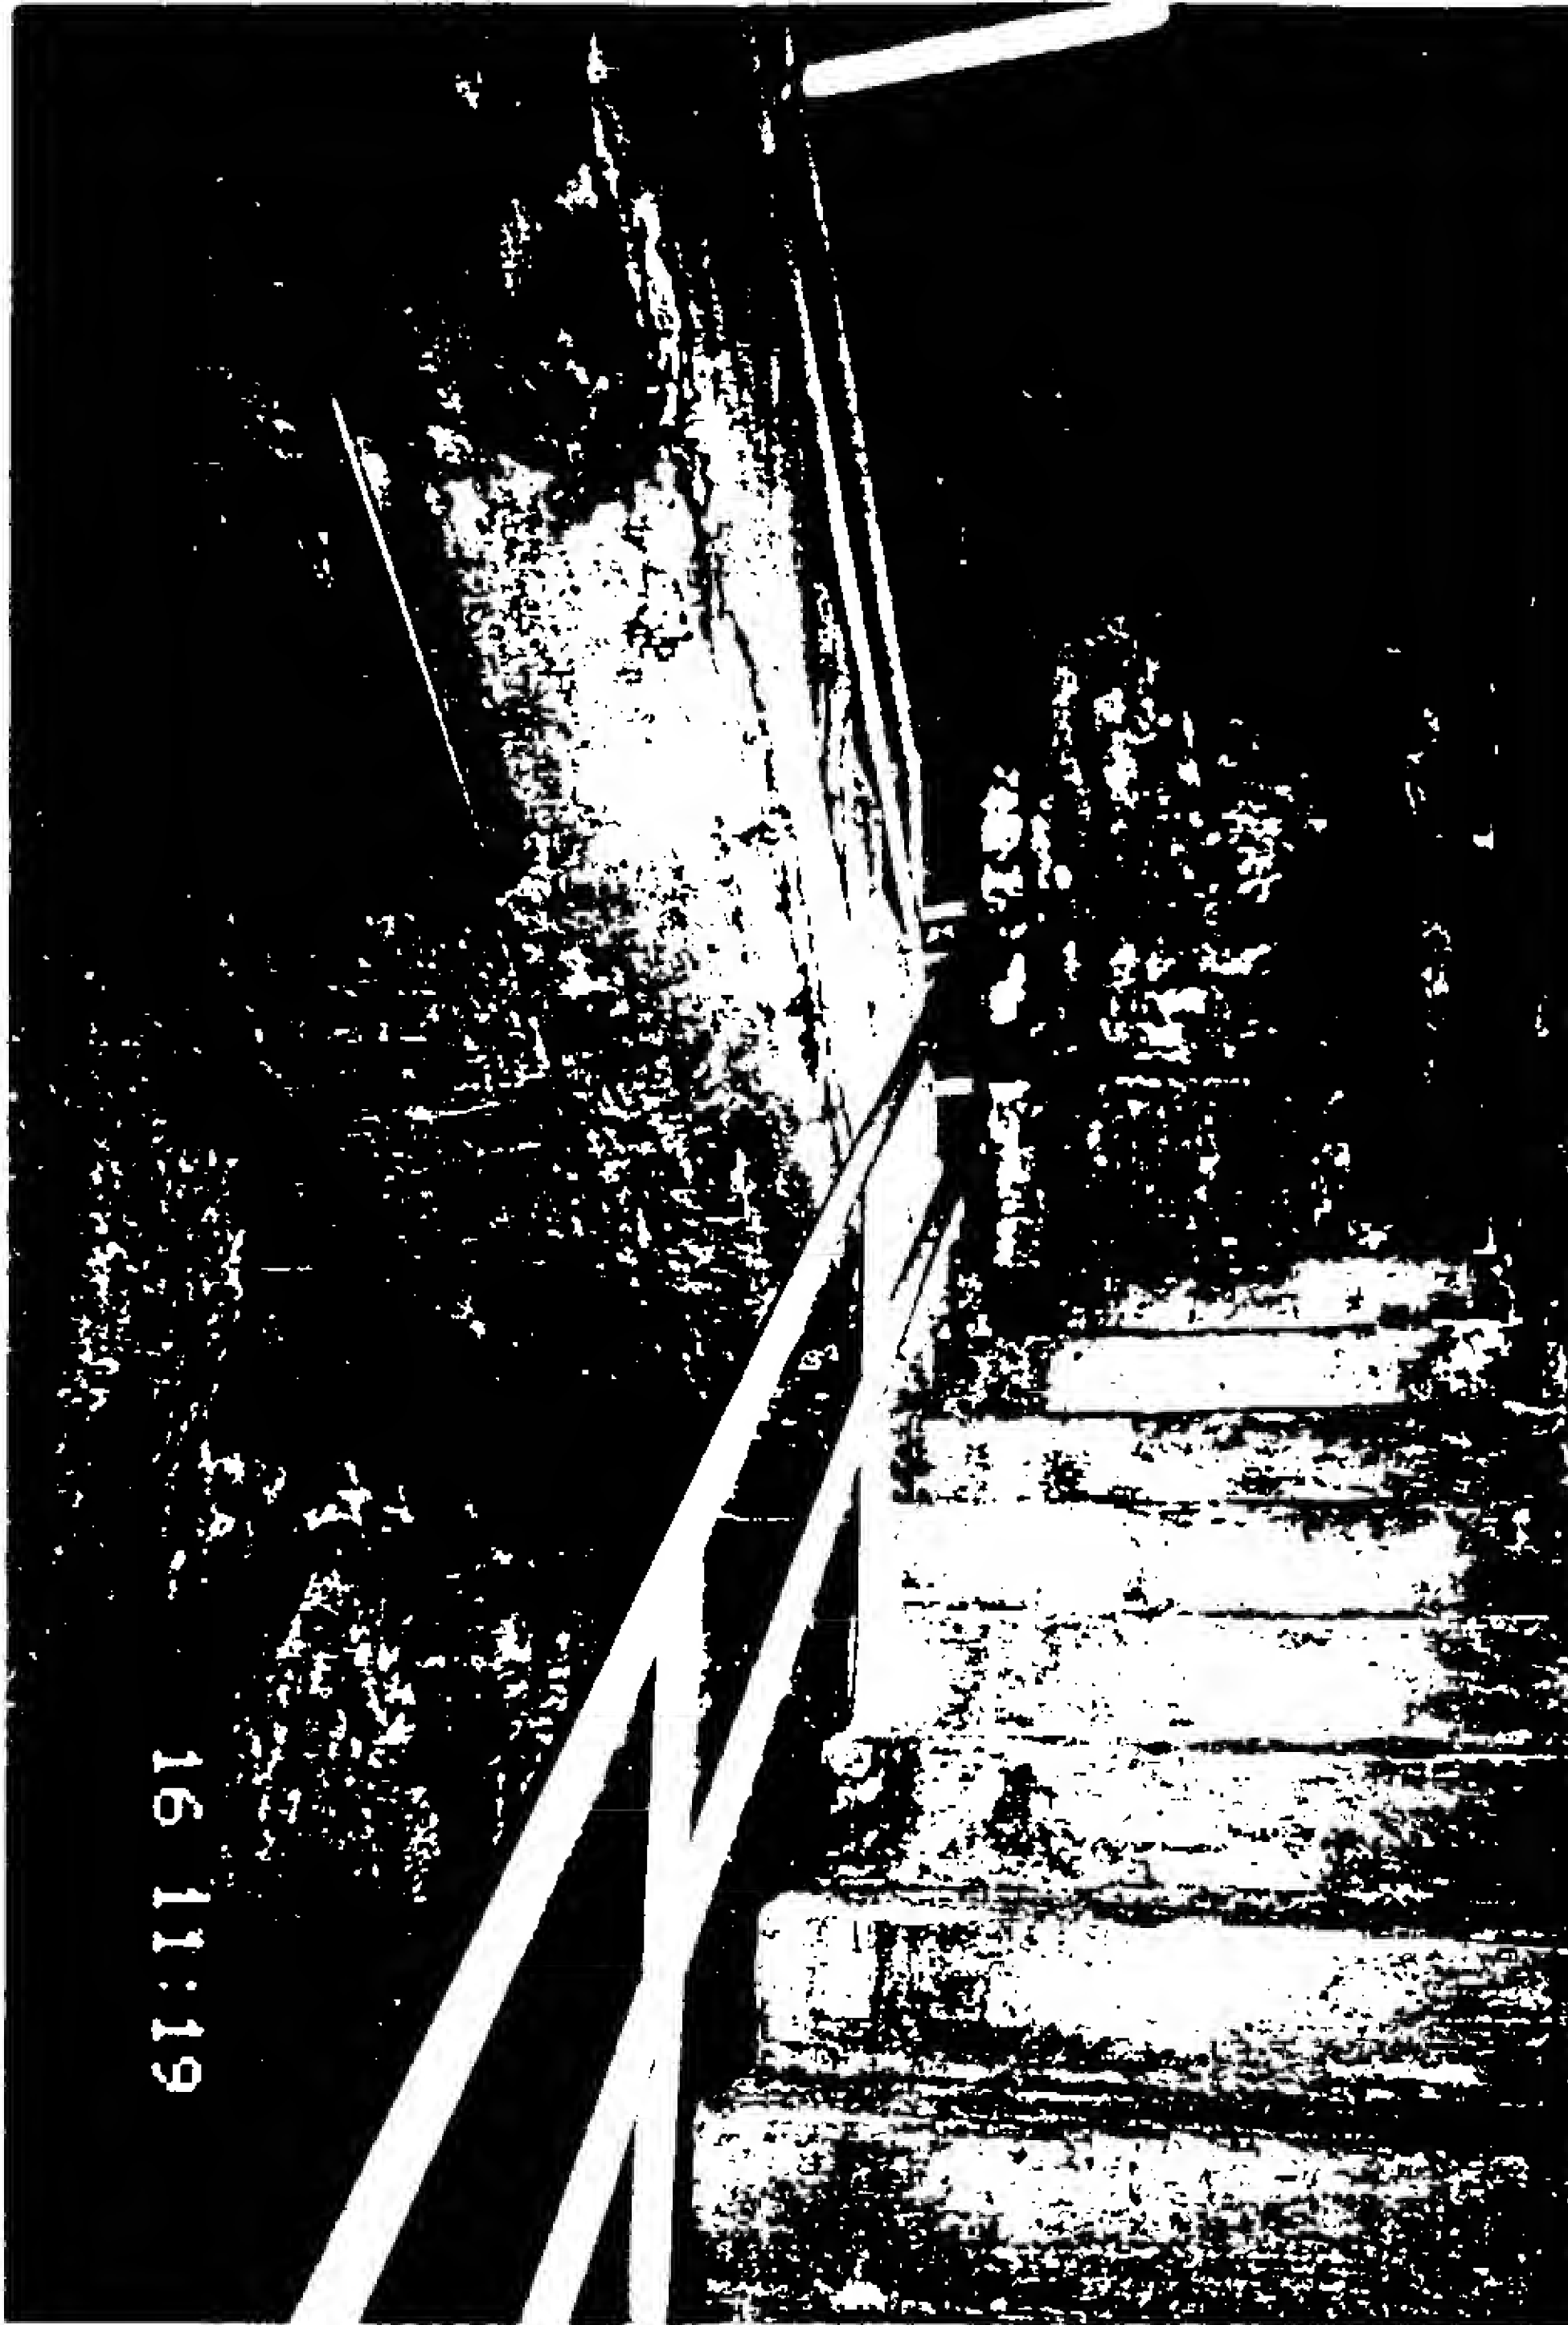
Photograph 21

Stair in projection
serves as PATH
emergency exit

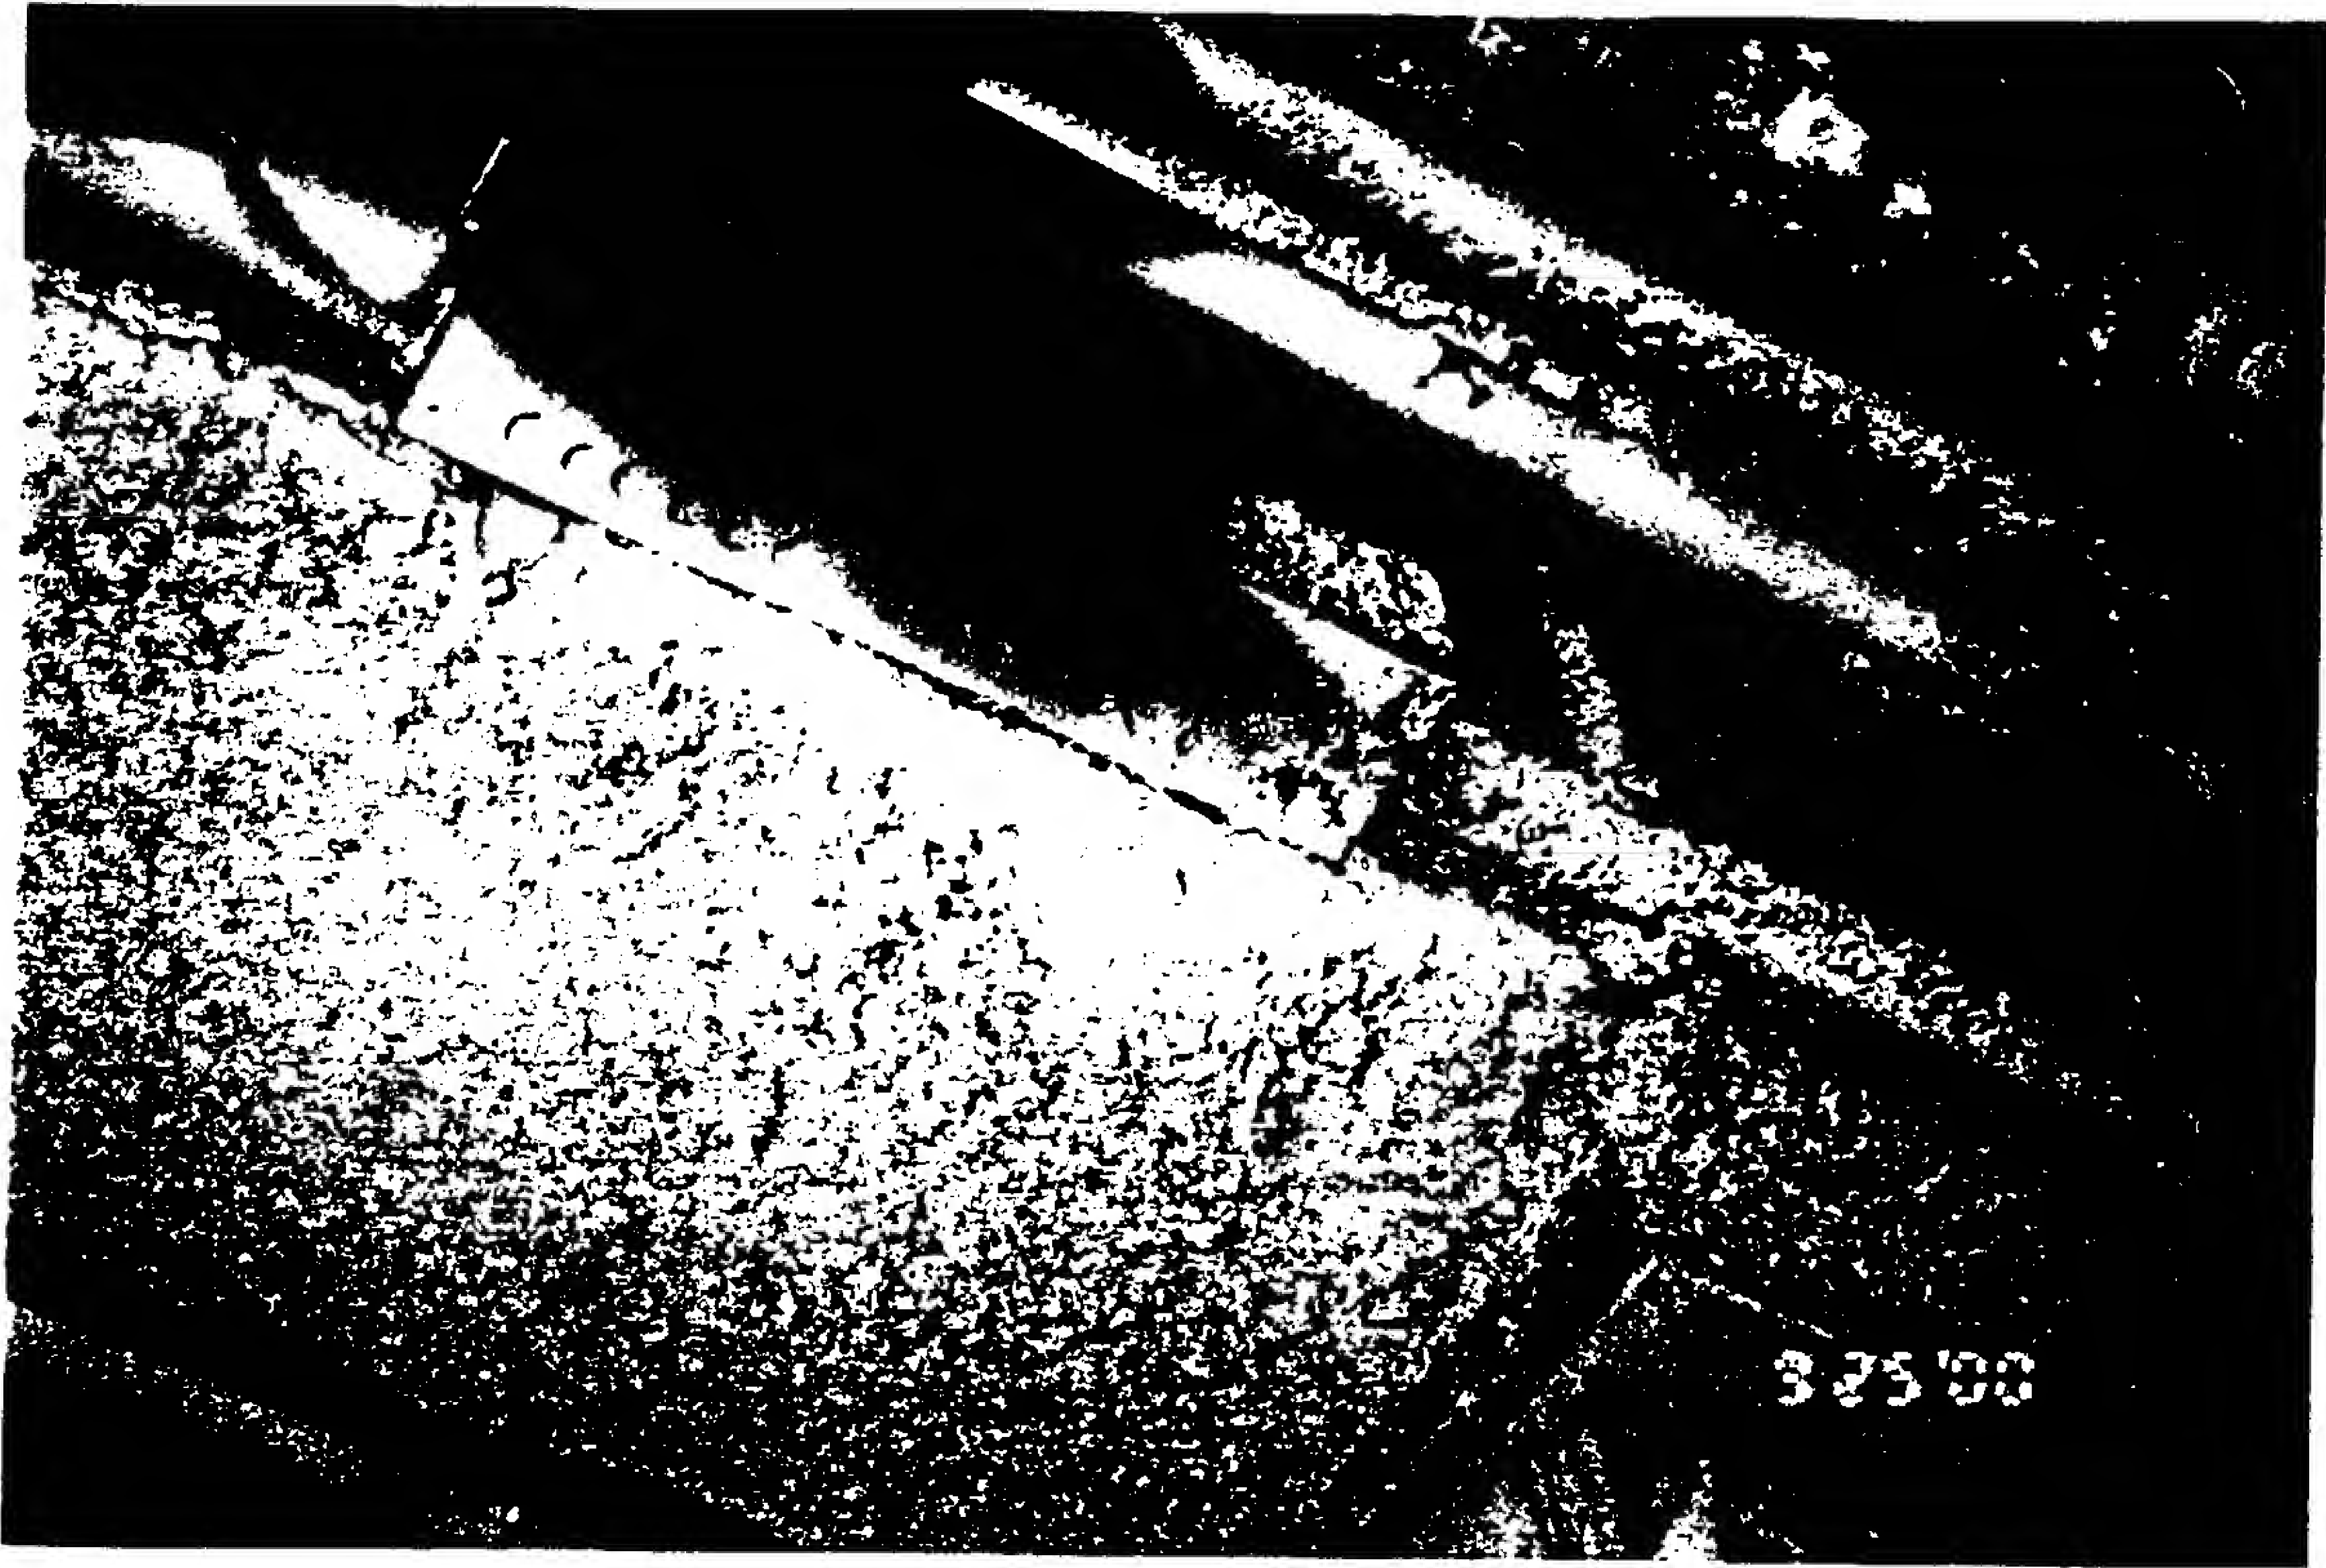
Information provided reports that there is no asbestos-containing fireproofing in the Subgrade parking areas. Thermal system insulation is present but quantities were not provided. Mr. Phillip Taylor reported that the asbestos-containing fireproofing at the U.S. Customs truck dock has been removed and replaced with non-asbestos fireproofing tinted blue. He reported that some small areas of "spot removal" has occurred and that approximately 5,000 square feet of asbestos-containing fireproofing at the main Port Authority truck dock was "encased" (actually encapsulated) and that the encapsulated fireproofing is tinted "whitish" (Photos #1 & 2). The remainder of the fireproofing (50,000 square feet) at the main truck dock is reported original and to be ACM.

Photo #1: Spray-on fireproofing, loading dock area.
